# MOLD, A POLTERGEIST

*Mold growing within the walls of a brick veneer home can pose special problems for diagnosis and remediation.*

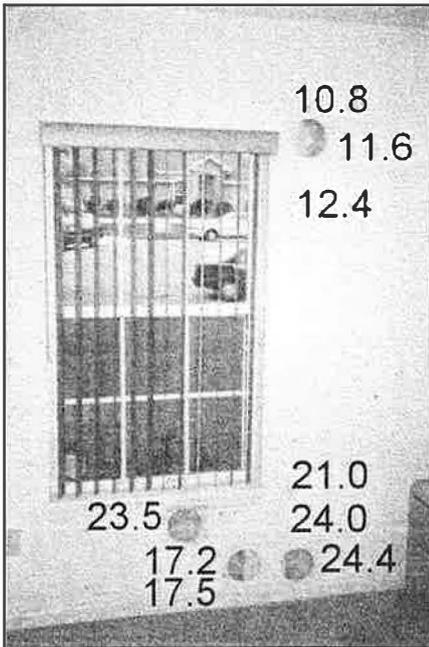
The immediate odor source turned out to be the east wall's waferboard sheathing, located between the brick veneer and the wood framing. Our noses targeted the sheathing, and we confirmed its high moisture content (17%–24%) with a highly accurate conductive moisture meter (see "Moisture Meter Selection," p. 21). The

moisture was located in a region below waist height. For wood panels, surface mold begins to form at about 17%, and rotting begins at about 27%. The sheathing that was above waist-height had a water content of 11%–12%. Determining the sheathing's water content was easily done with special deep probes designed to penetrate the interior gypsum board with minimal damage and to continue past the wall insulation, without measuring the water content of either.

At 17% moisture content in a wall, mold growth begins; at 27% rotting may begin.

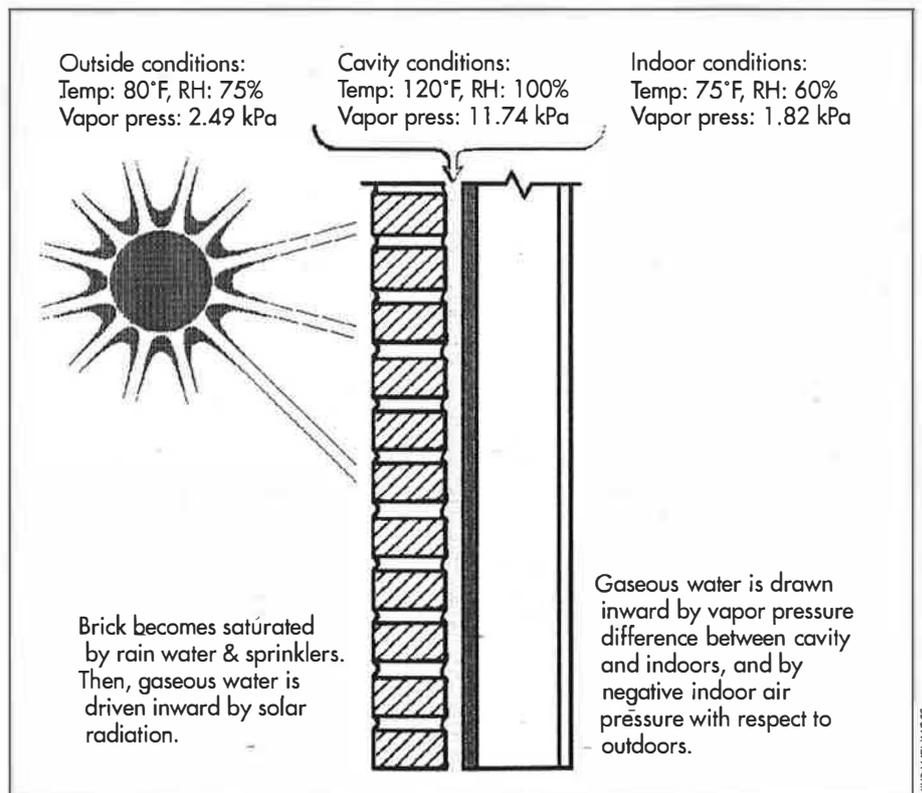
Figure 1. Note the relative humidity of 100% that occurs in the cavity between the brick and the sheathing cavity when the water-soaked brick is heated by the sun.

In our troubled house, moisture damage occurred from the following process. The face brick was absorbing liquid water from rain and from sprinklers. This water in gaseous form was then being driven inward by solar radiation. The relative humidity within the brick-sheathing cavity was 100%, or complete air saturation (see Figure 1). Because the indoor pressure with respect to outdoors was always 0.5–7 Pa negative, the gaseous moisture was being drawn into the waferboard sheathing and into the wall cavity, and odors were carried indoors by the incoming diffuse airstream. The gaseous moisture also passed around the interior windowsill, causing it to warp. The higher moisture content low on the sheathing may have been caused by extra water loading from irrigation sprinklers, which were striking the face brick below mid-window height. Also, the roof overhang shields the upper brick courses from some solar radiation, reducing the tendency for moisture to be driven inward there.

Fundamentally, the high sheathing moisture content could be traced to duct leakage, incorrect duct sizing, and poor sprinkler head location. A primary cause,

defective veneer wall construction, could not be easily corrected.

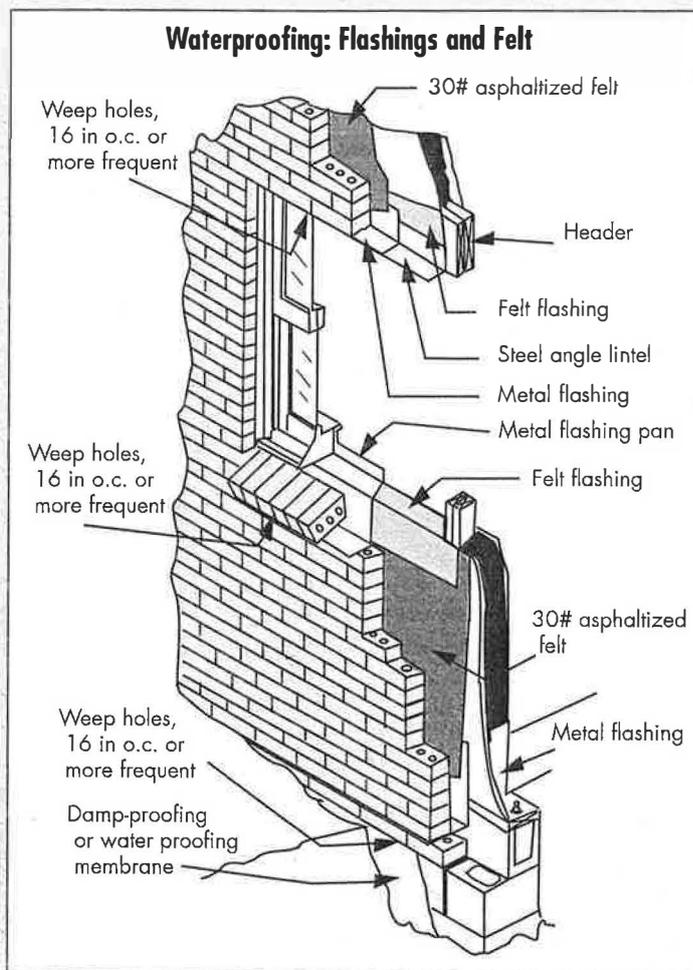
Figure A. Proper location of flashings and weep holes, as well as correct matting of flashings with asphaltized felt, helps avoiding moisture intrusion.

**Flashings.** The specific locations of flashings are shown in the attached illustrations. Consistent with BIA standards, they should be located above and below windows and at the bottom of the wall,

and they should pass through the brick course and have a drip edge on the outside. In many cases the flashing under the window should be a flashing-pan whose three inner edges are turned up and corners soldered. All flashings should be overlapped by the 30 pound felt. Weepholes must be placed every 16 inches along the flashing. In coastal areas Type 316 stainless steel flashing material is recommended. Avoid the use of any material, including foam caulk, to seal the cavity between wood shim-mounted windows and the rough framing. Any obstructions in this cavity will prevent intruding water from draining to the flashing pan below the window and contribute to window rotting.

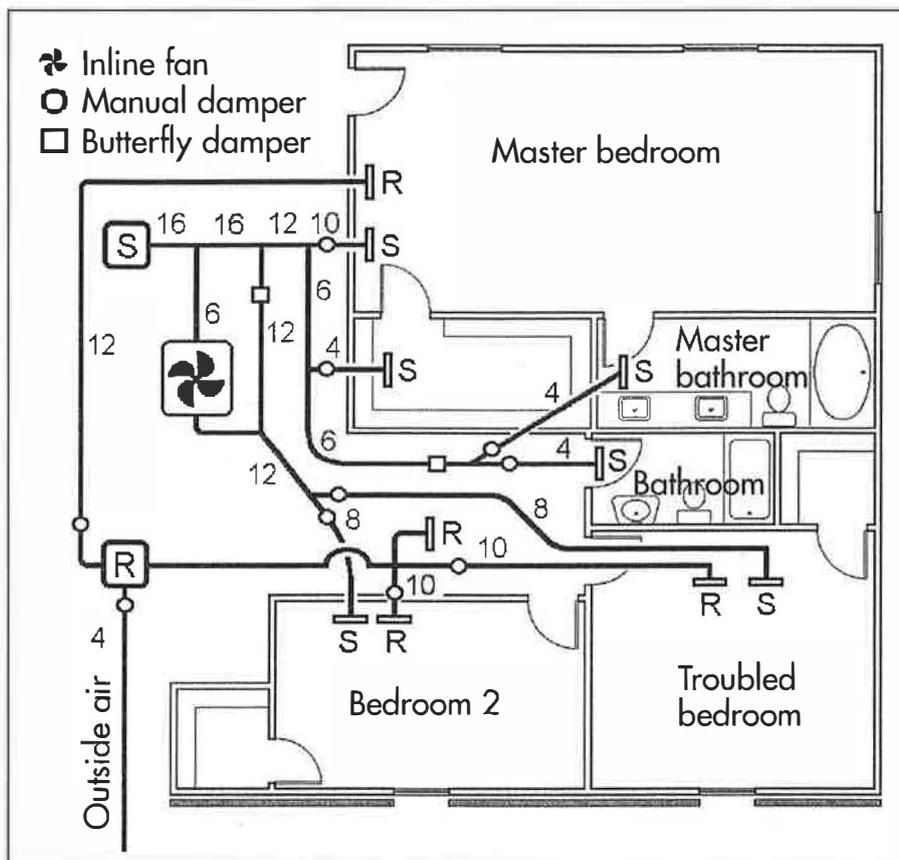
Figure 2. A bypass loop was created, equipped with a one-way butterfly damper, to ensure air delivery solely to the intended destinations. Manual dampers on all the returns allowed us to reduce each return air flow till the receiving room pressure was neutral or positive with respect to outdoors.

**Correct the air flow.** The measured air flows to all the bedrooms, including the troubled room, were compared to the required air flows as determined by careful load calculations, and were found to be deficient—not enough dehumidified air was being supplied to manage the moisture loads. The owners had complained that these rooms were always too warm in summer and too cold in winter. The principal trunk and all the bedroom branches were replaced with very large diameter ductwork, and the joints were sealed with fabric-reinforced mastic (see Figure 2 on p. 23). The air flow to Megan's

**Provide constant air flow to the troubled rooms.** Corrections were initiated in the fall when A/C use and blower fan on-time are minimal. To maintain constant air flow and pressurization for the more troubled bedroom during the drying-out period, a temporary 120 CFM inline fan was installed in the supply duct leading to that bedroom. The fan was located near the trunk to reduce noise. The relay controlled fan operates only when the main air handler fan is off (see Figure 2).
